Preliminary Report on the Performance of the New Orleans Levee Systems in Hurricane Katrina on August 29, 2005

Preliminary findings from field investigations and associated studies performed by teams from the University of California at Berkeley and the American Society of Civil Engineers, as well as a number of cooperating engineers and scientists, shortly after the hurricane.

Report No. UCB/CITRIS – 05/01
November 2, 2005

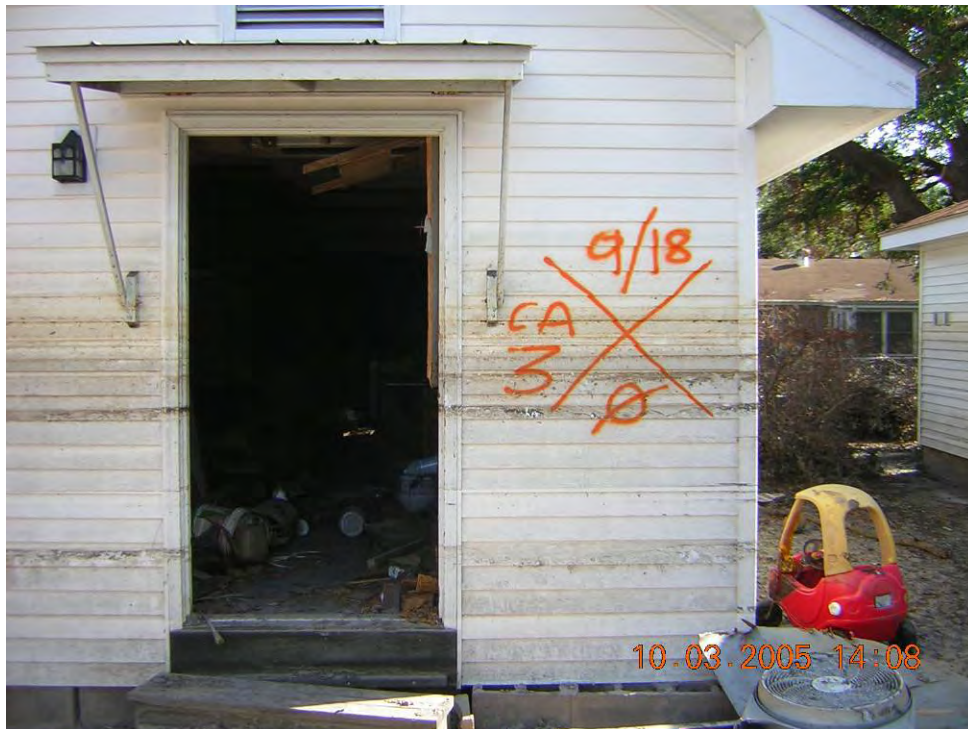
Neighborhoods that were inundated exhibit stark evidence of this catastrophic flooding. Water marks, resembling oversized bathtub rings, line the sides of buildings and cars in these stricken neighborhoods, as shown in Figure 1.8. Household and commercial chemicals and solvents, as well as gasoline, mixed with the floodwaters in many neighborhoods, and at the time of this investigation's first field visits the paint on cars below the watermarks on adjacent buildings had been severely damaged, and bushes and shrubs were browned below the watermarks, but often starkly green above. Driving through neighborhoods that had been flooded, there was often the impression that one was viewing a television screen where the color of the picture was somehow distorted or altered below a horizontal line; the level at which the floodwaters had been ponded. The devastation in these neighborhoods, and its lateral extent across many miles of developed neighborhoods, was

Figure 1.8: High water marks remain on structures after temporary levee repairs have been completed and flood waters have been pumped out.

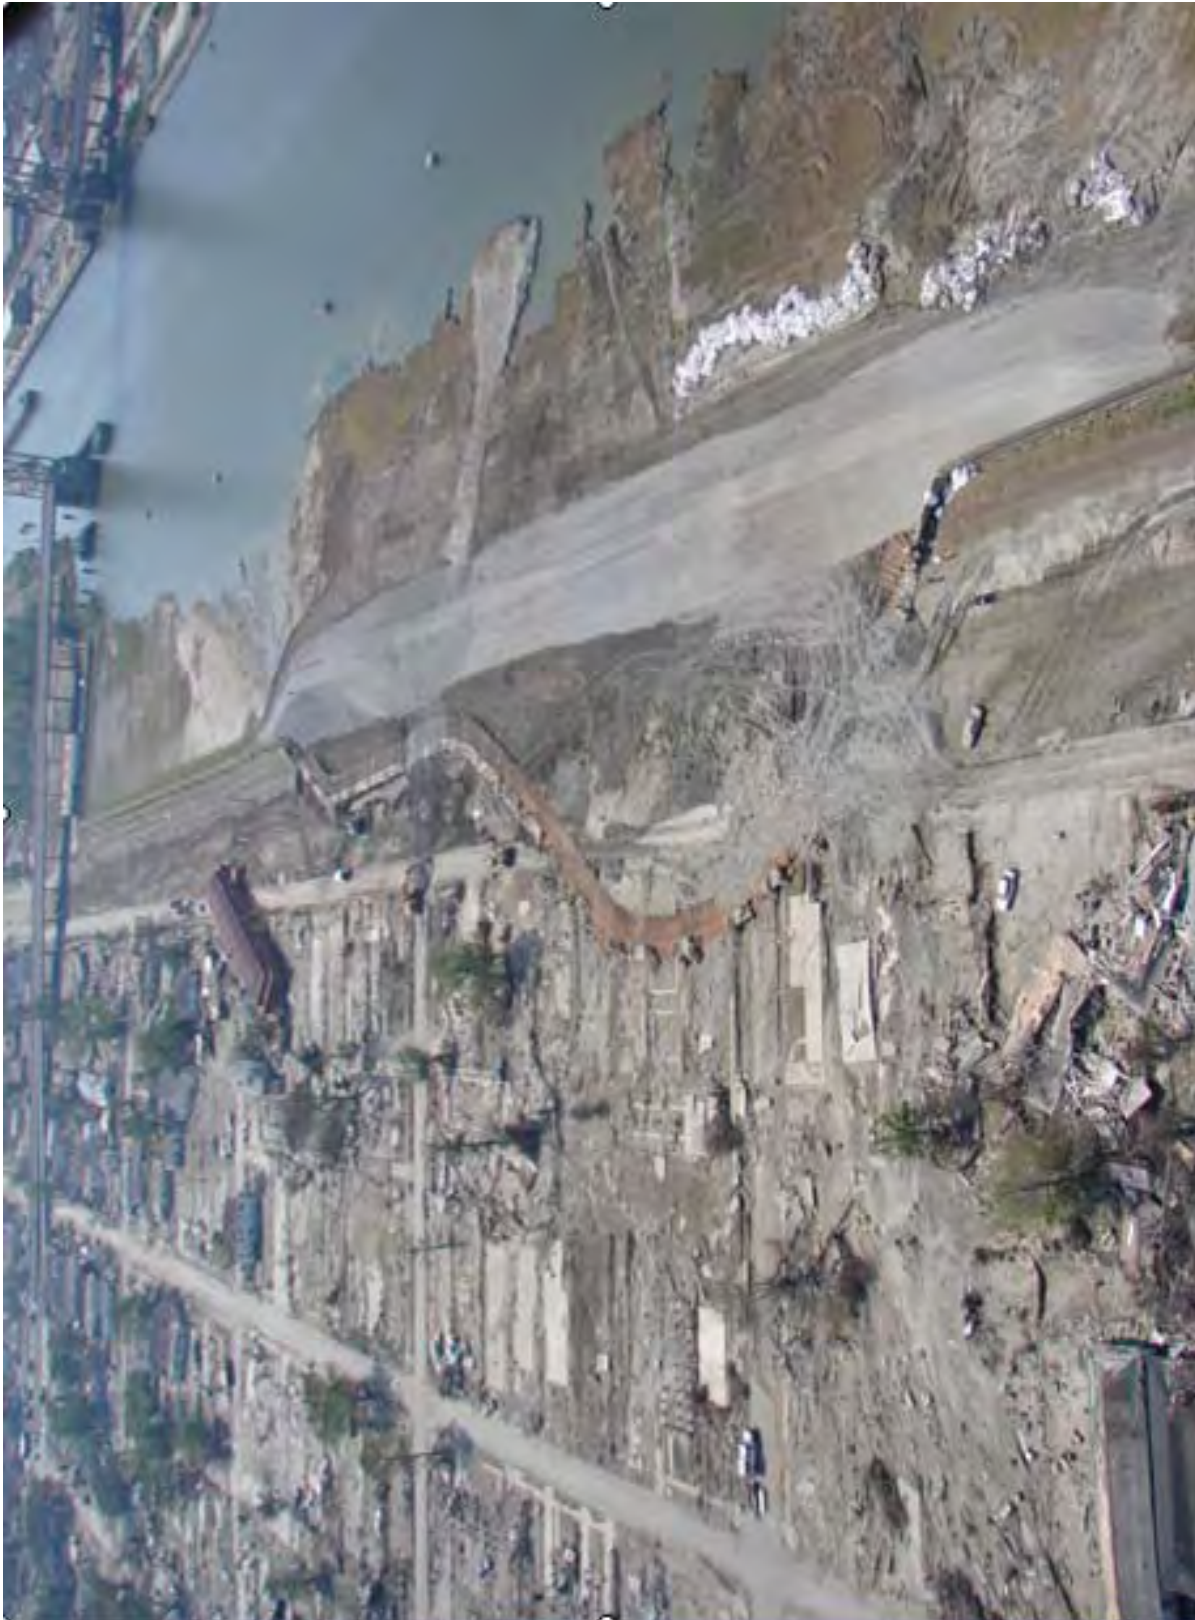
Figure 1.9: Oblique view of the (south) levee break at the Inner Harbor Navigation Canal into the lower Ninth Ward.

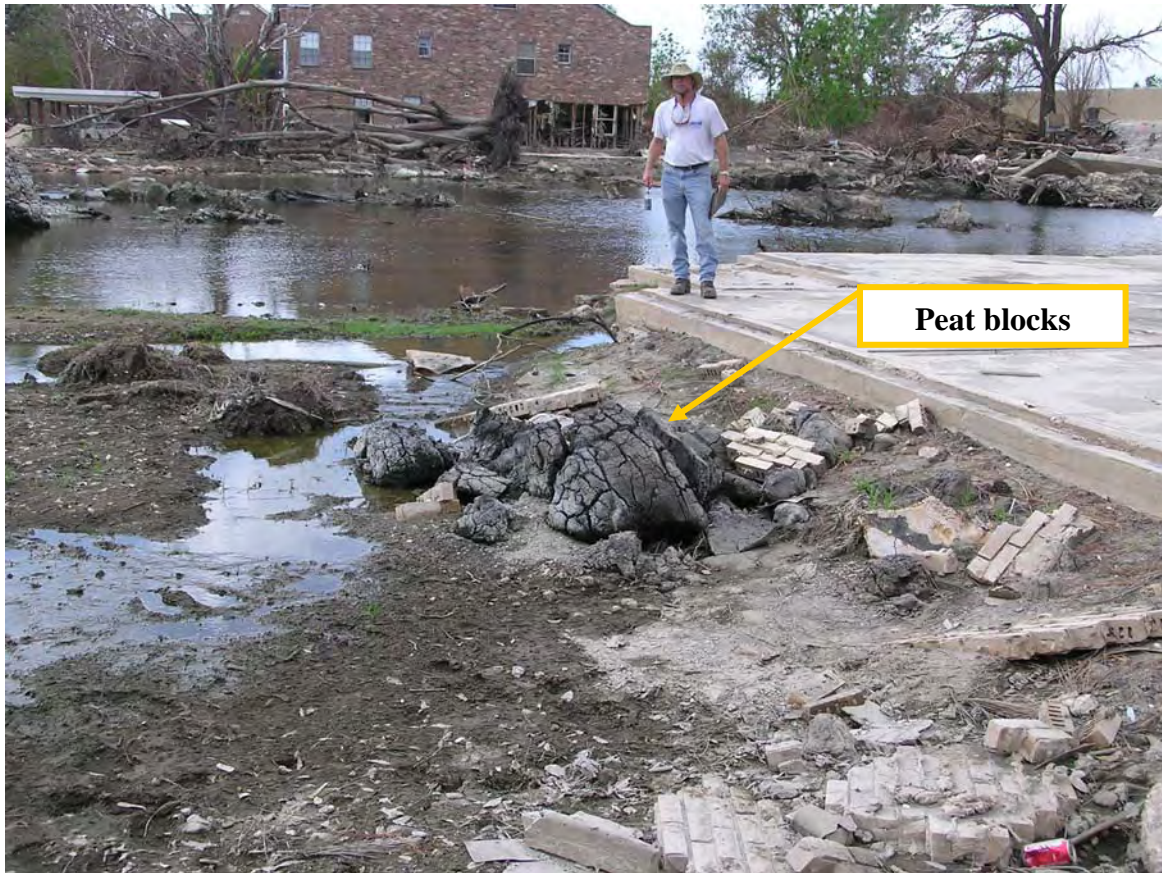
Figure 2.5 shows a view looking south across the zone through which the principal floodwaters flowed. Clearly evident in this photo are large blocks of peat scoured from the eroding foundation by the floodwaters.

Figure 2.5: View from crest of emergency embankment closure section at the 17th Street Canal breach, looking south across the floodwater scoured zone.

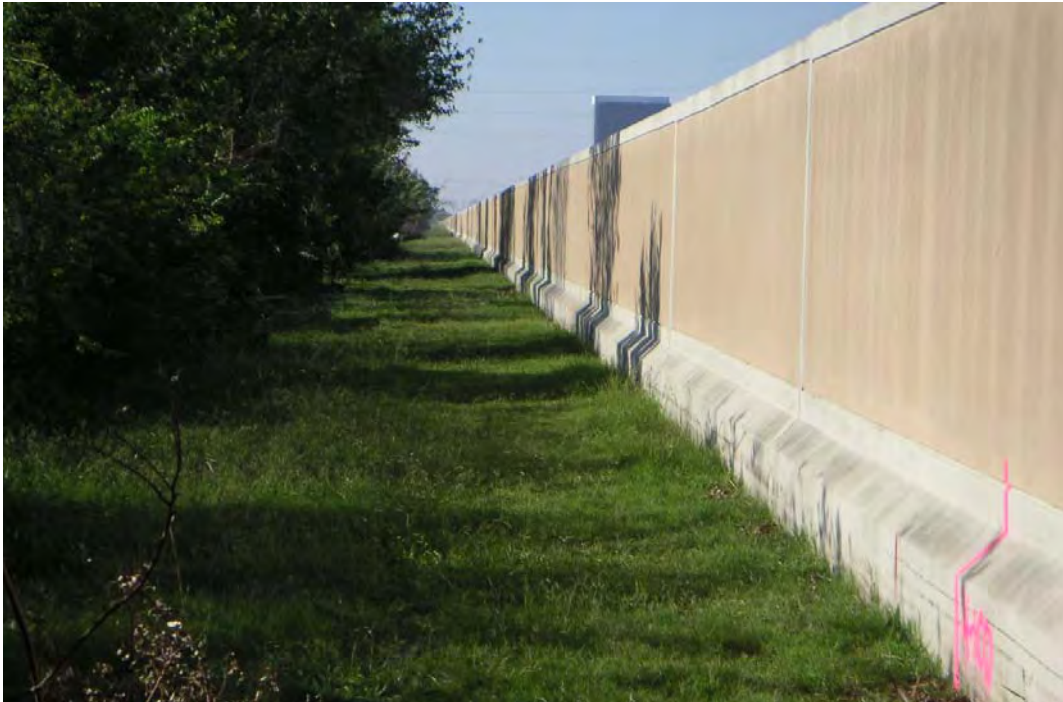
Figure 2.11: Typical conditions at the inboard side of floodwalls along the 17th Street Canal showing no scour of soil at the toe of the wall.

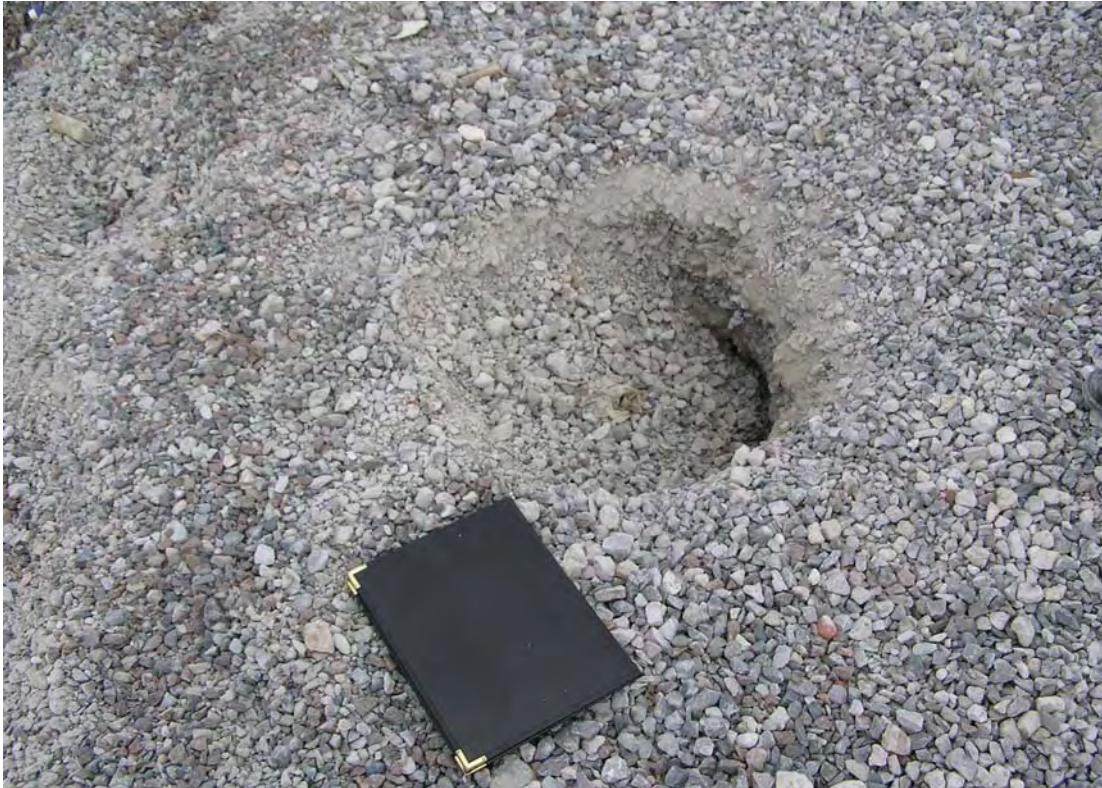
Figure 2.13: One of four sinkholes noted at the front lip of the crest of the temporary closure section embankment.

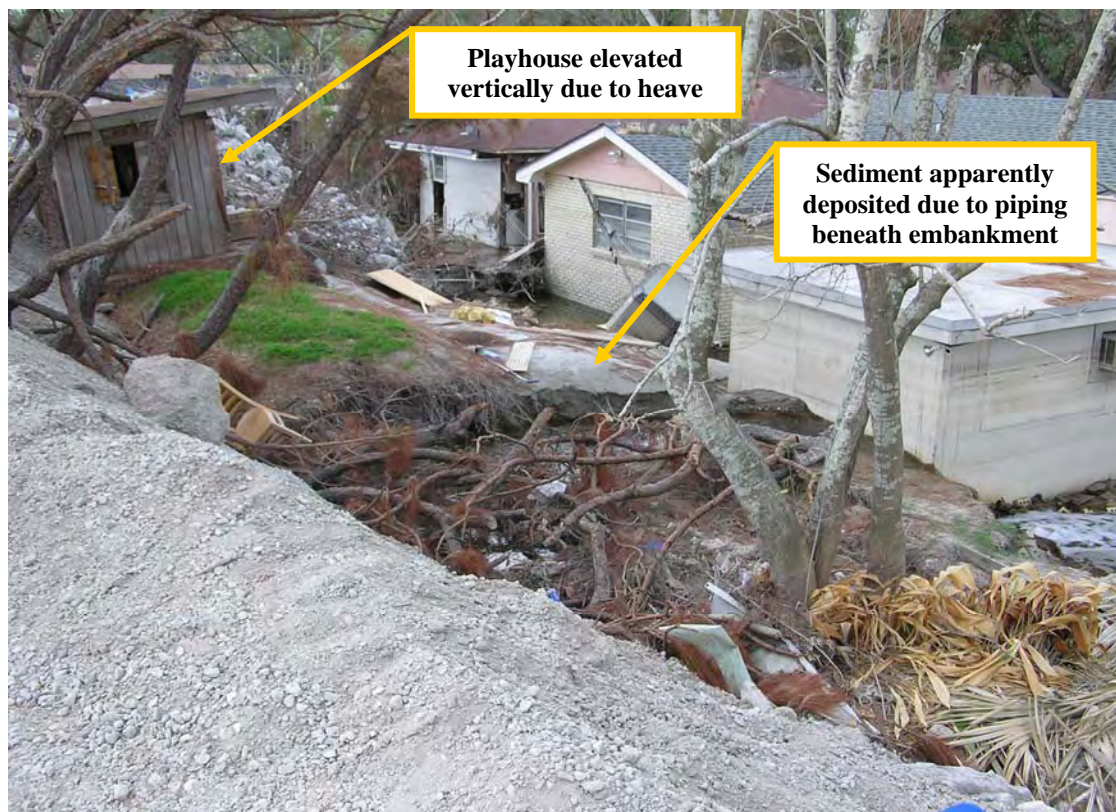
Figure 2.16: Conditions at the inboard toe of the London Avenue Canal (North) breach section.

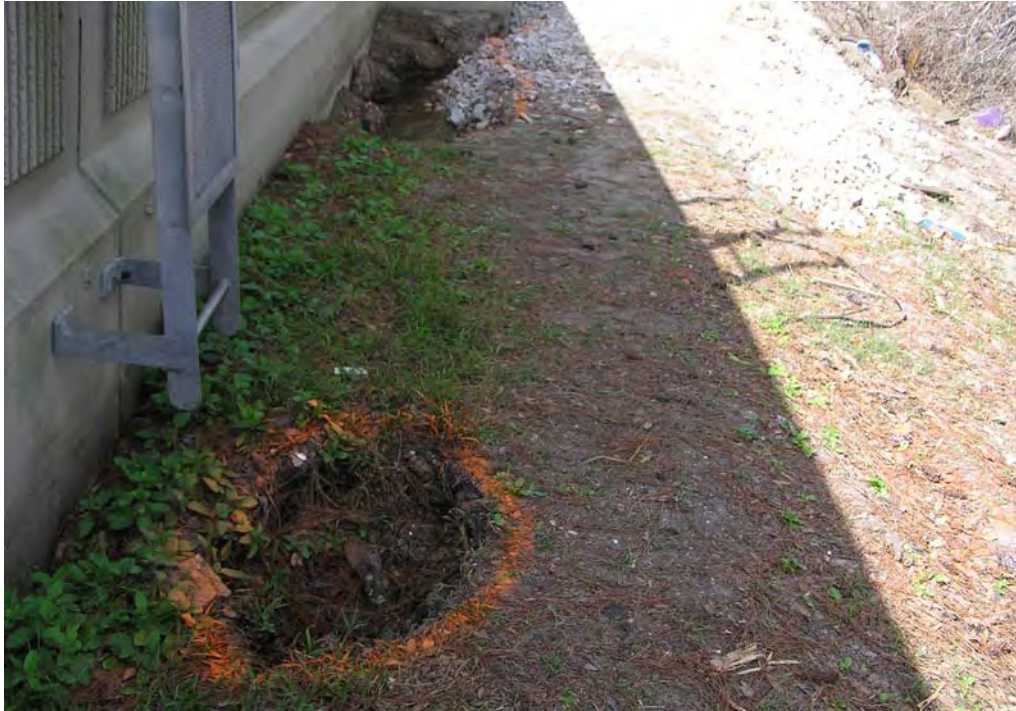
Figure 2.21: Closeup view of sinkholes at the inboard toe of the floodwall, at the location of the engineer wearing a red shirt in Figure 2.20.

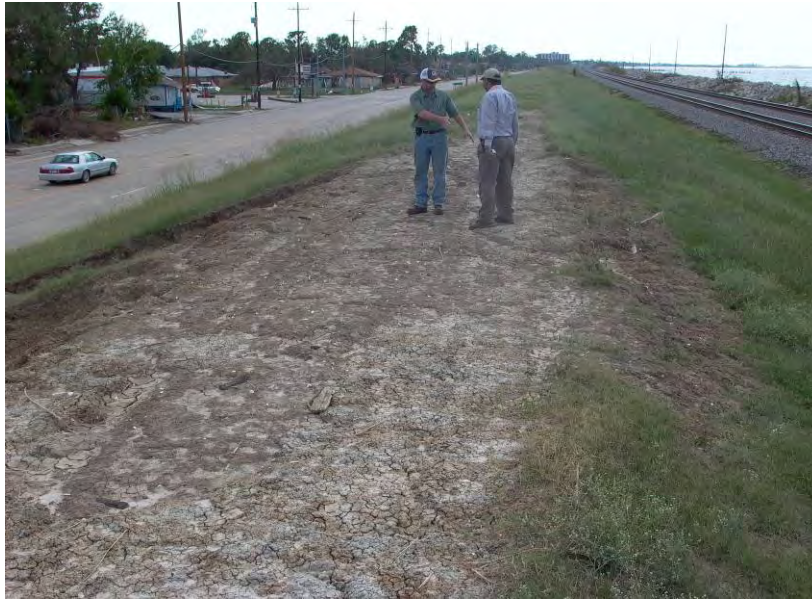
Figure 3.6: Wave overtopping of lakefront earthen levee at low spot in structure did not cause serious damage (Photo by F. Silva – N 30° 03' 47.8", W 89° 58' 13.1)

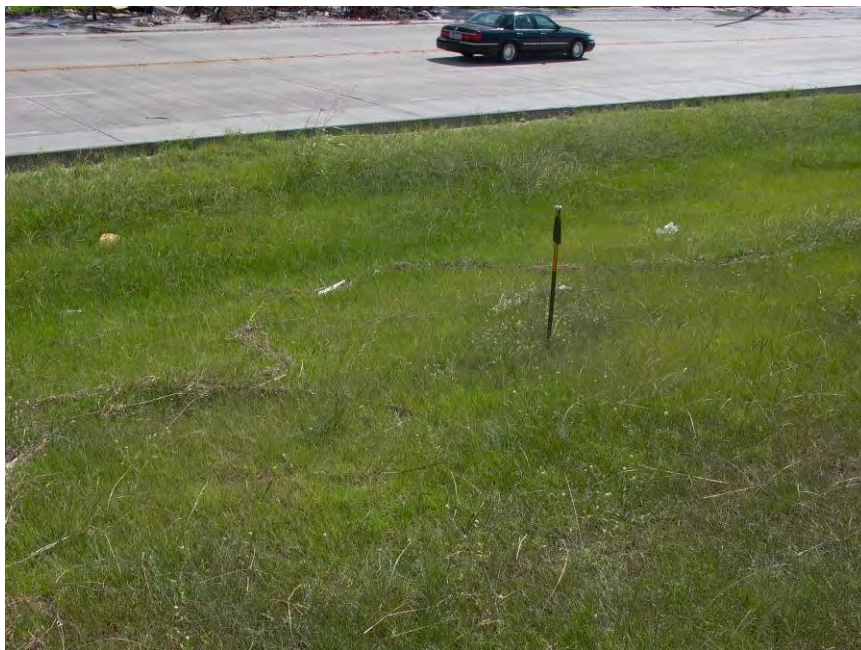
Figure 3.7: Debris line indicating prior sheet flow, most likely from wave overtopping or "splash-over", on landside slope of lakefront levee (Photo by F. Silva – N 30° 03' 47.8". W 89° 58' 13.1")

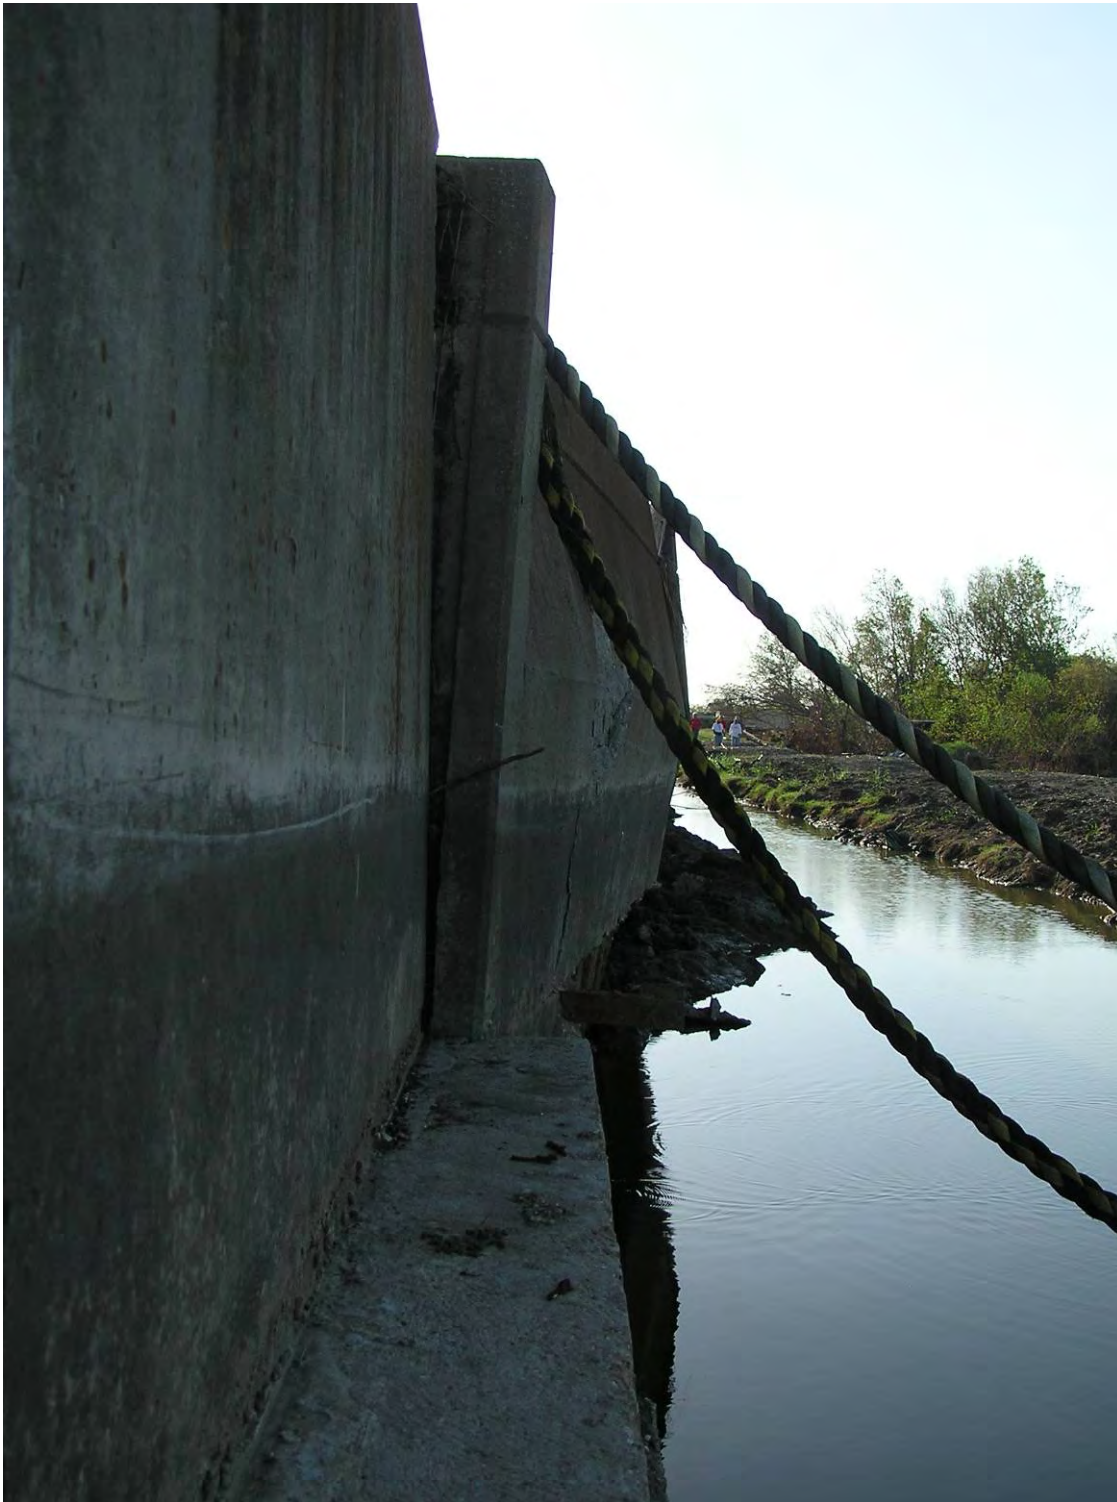
Figure 3.11: Undamaged T-wall in foreground and damaged I-wall in background along the Intracoastal Waterway. Severe scour on the landside and distress of the I-wall (N30.00030 W89.99459).

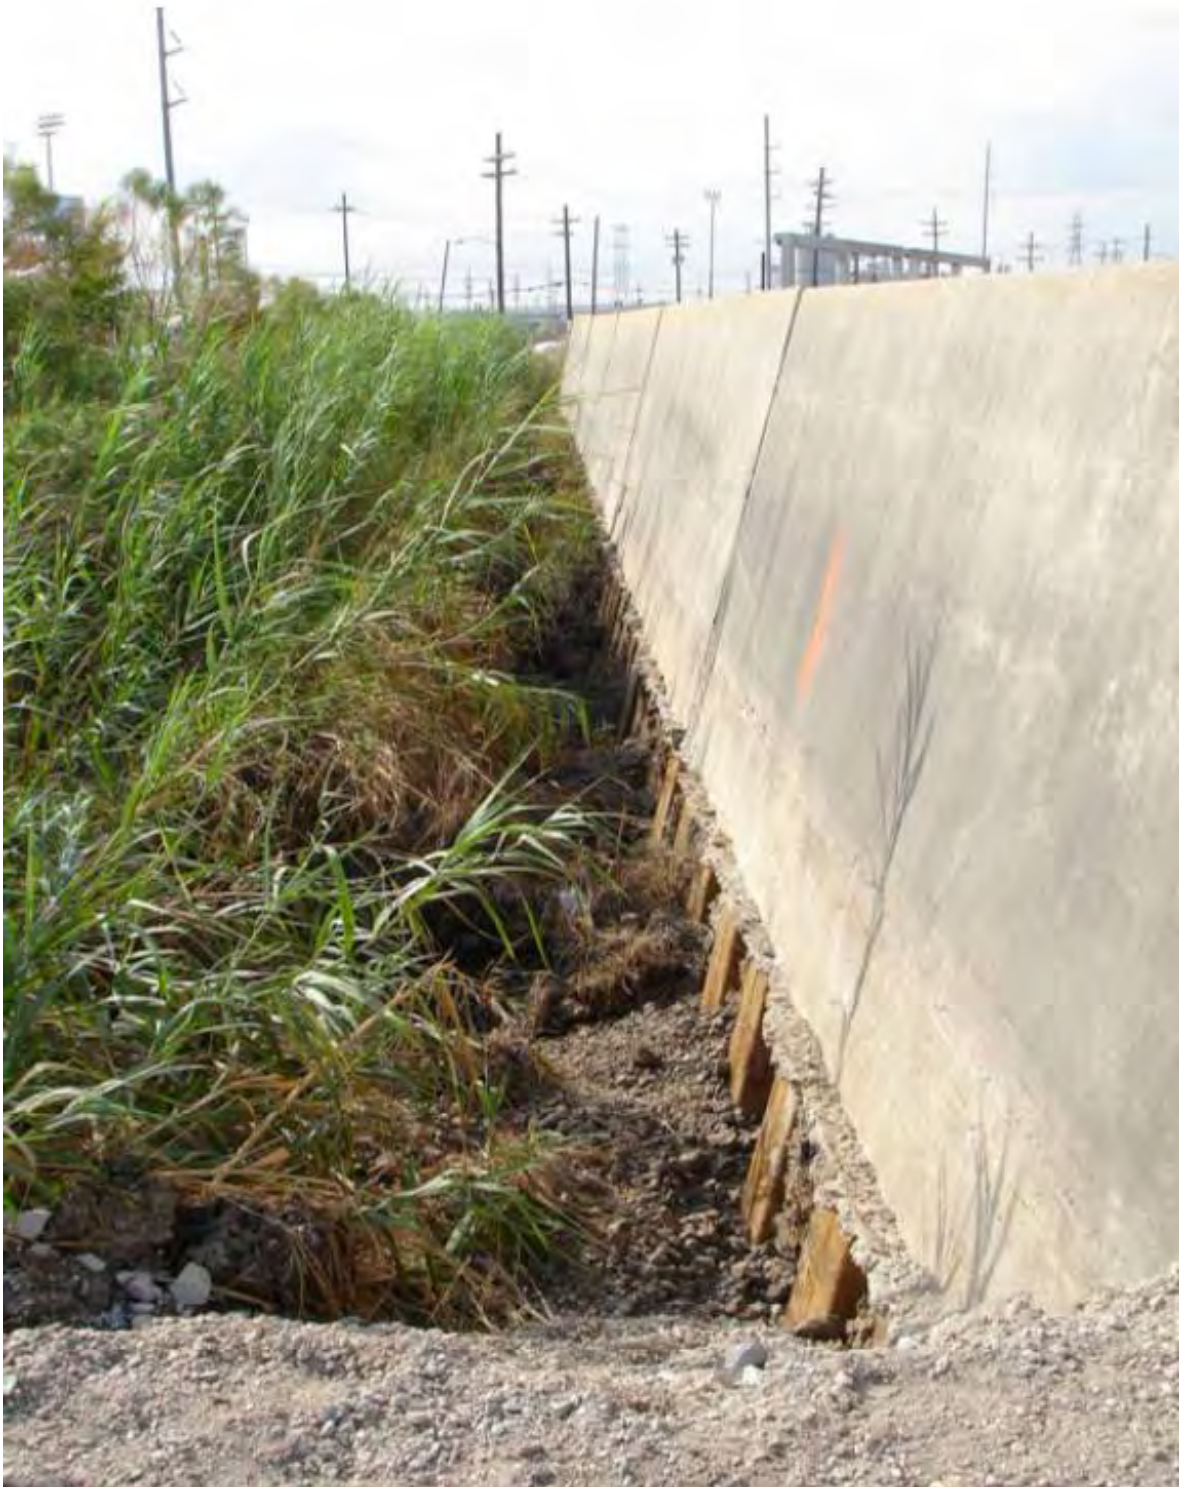
Figure 3.12: “Gapping” between soil and wall as distressed wall was displaced landward from the Intracoastal Waterway.

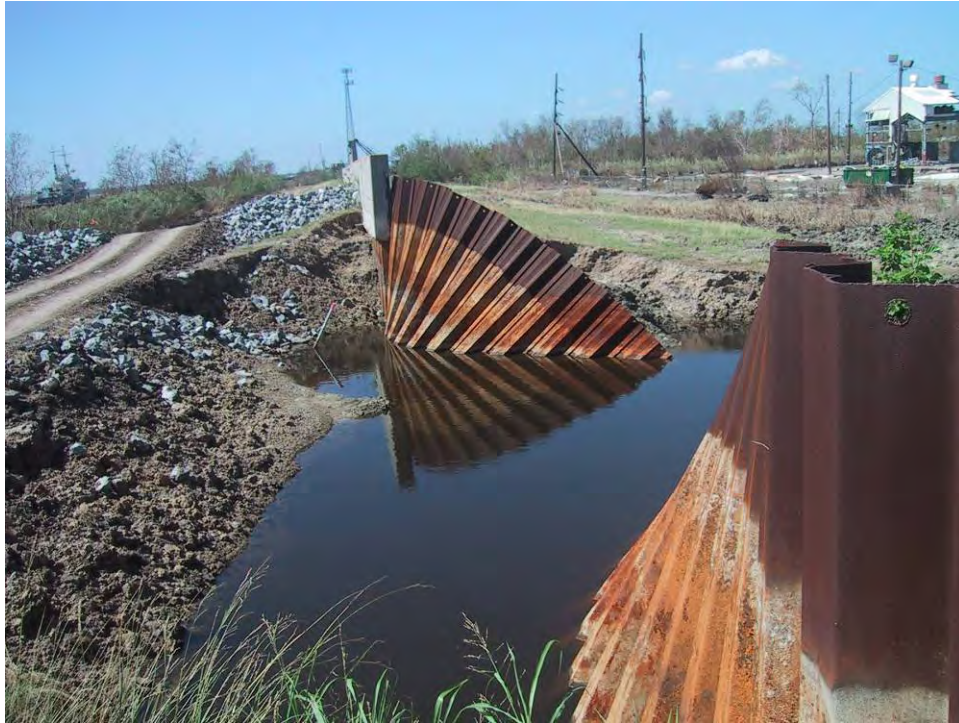
Figure 3.13 Failure of sheetpile wall adjacent to higher and stronger concrete topped I –wall on the north side of the IW.

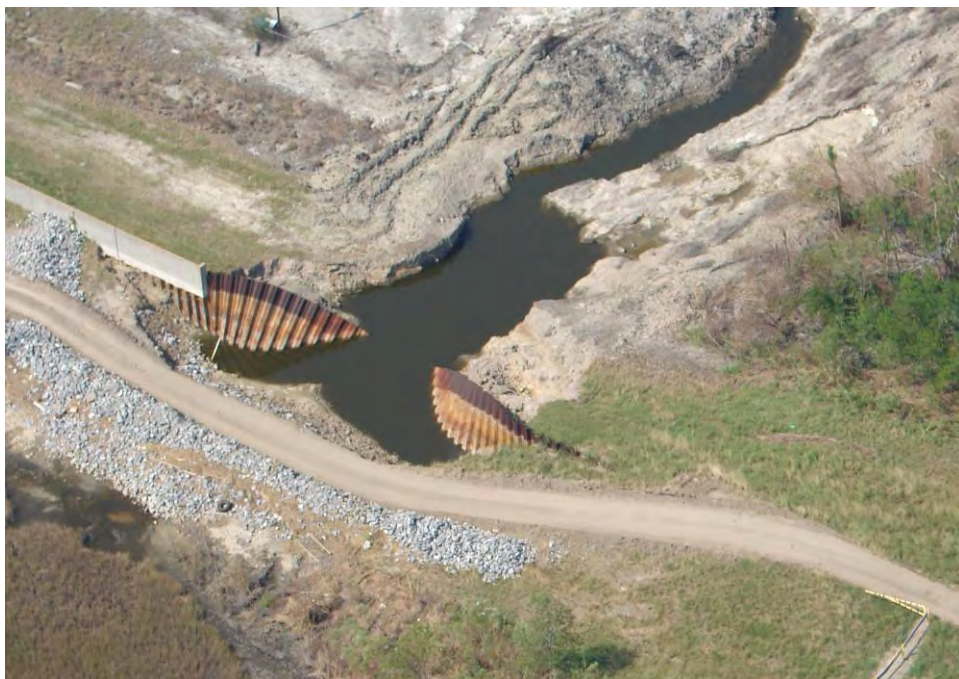
Figure 3.14: Aerial view of the failed wall section shown in Figure 3.13

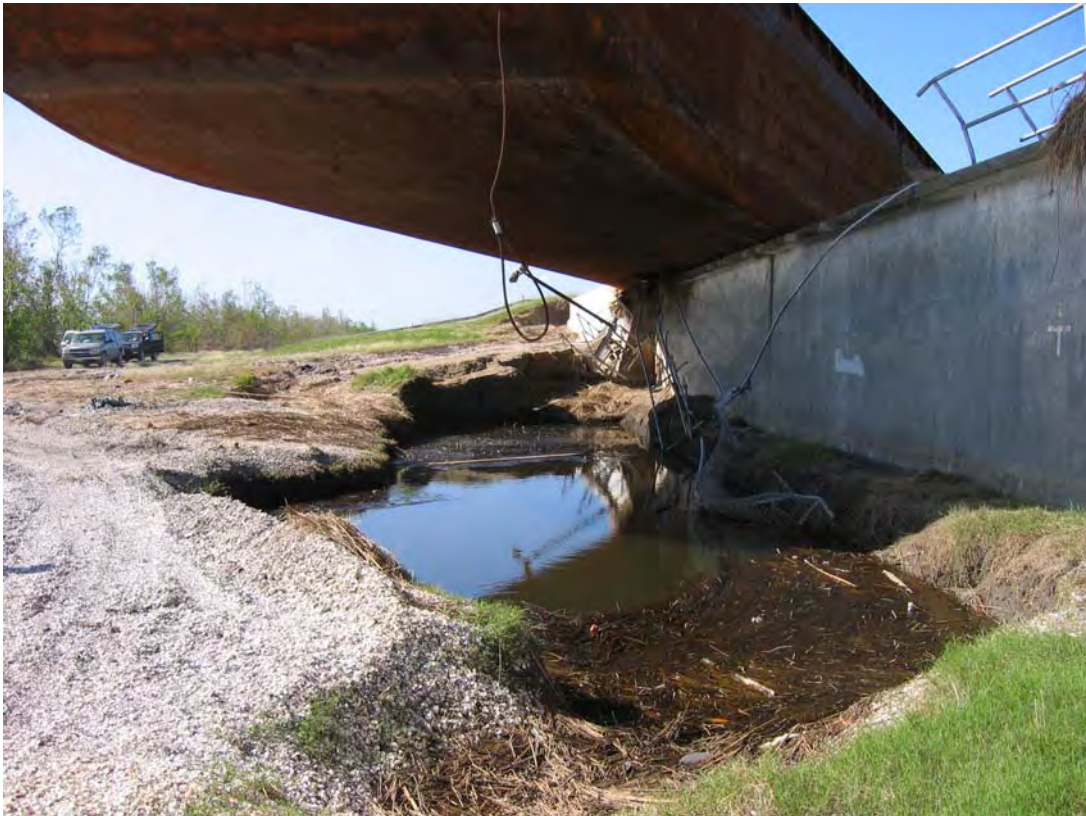
Fig. 4.14: Scour near barge damage at the Bienvenue Gate site (J. Wartman, October 5, 2005).

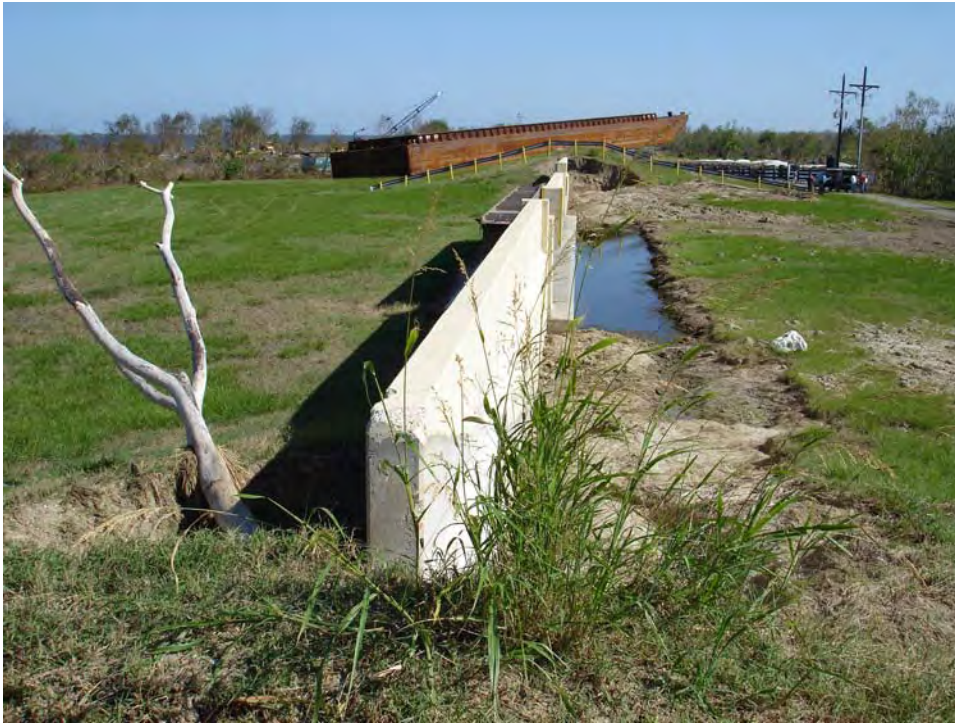
Fig. 4.15, Scour near Bienvenue Gate site (L. Wooten, October 5, 2005).

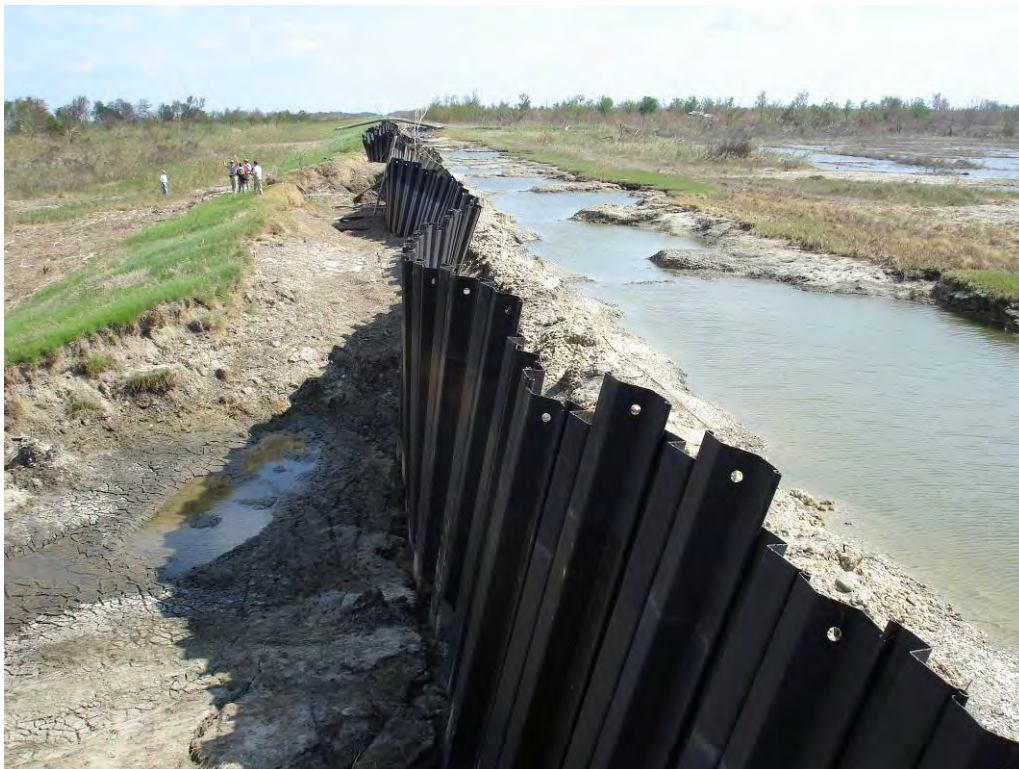
Fig. 20, Failure of earth levee with steel sheetpile barrier on the southeast bank of the MRGO. Note severe erosion and scour (L. Wooten, October 6, 2005).

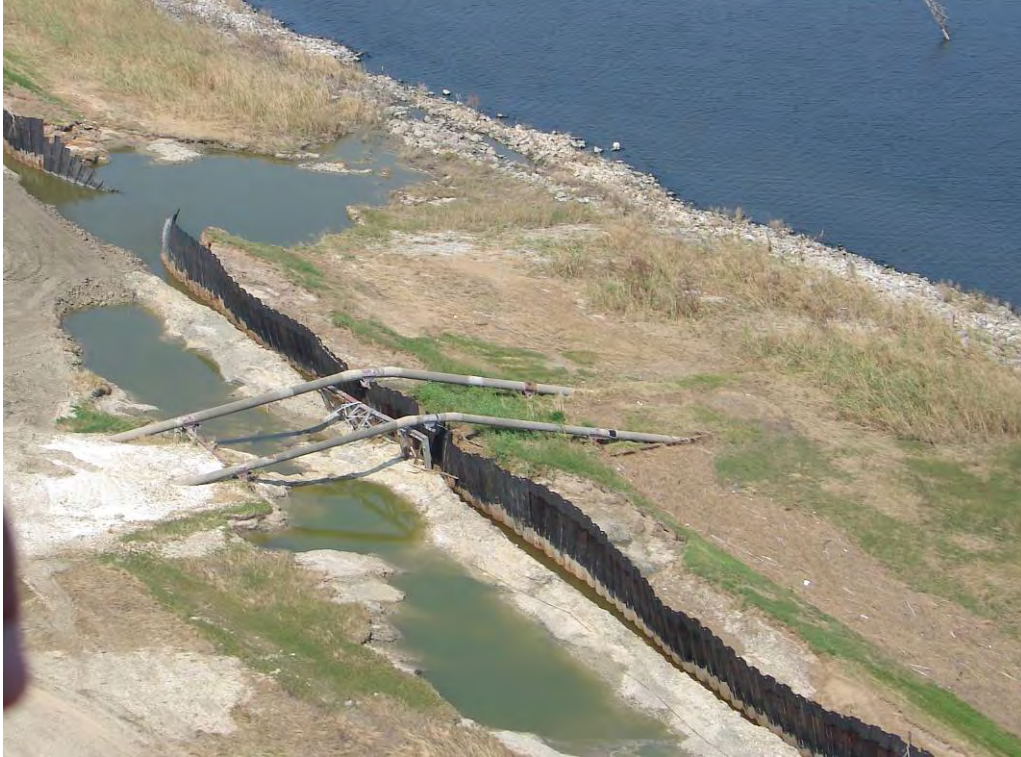
Fig. 21, Levee failure on southwestern bank of MRGO between Bayou Bienvenue (where barge is aground on I-wall) and Bayou Dupree. Note severe erosion and scouring (L. Harder, October 14, 2005).

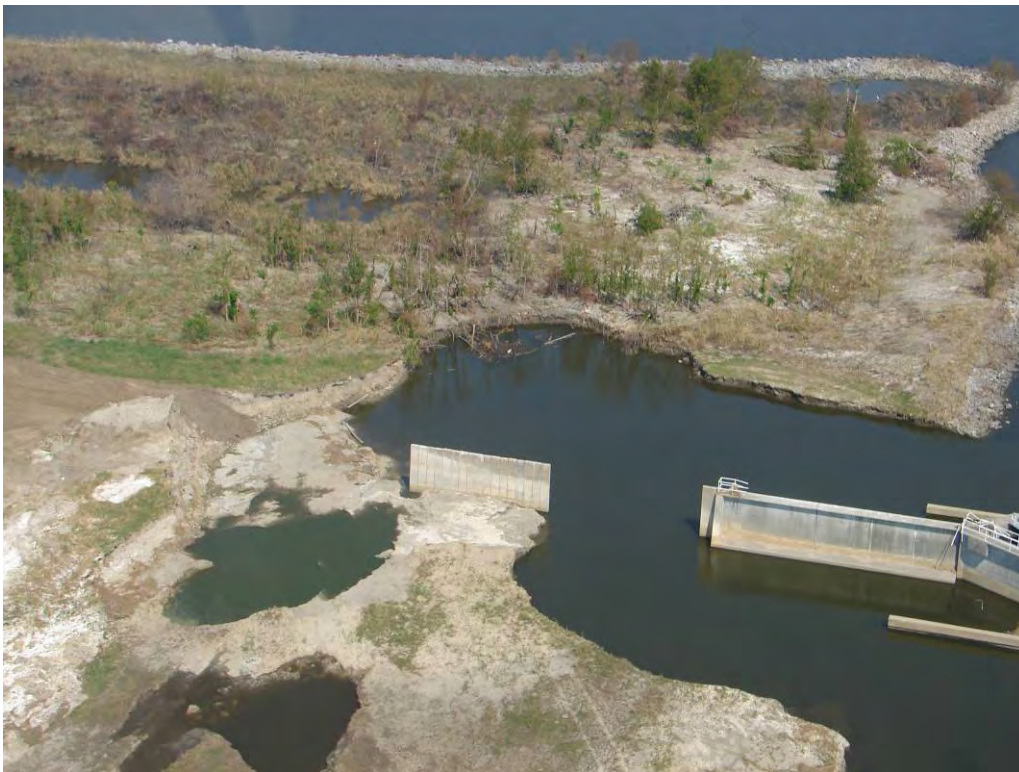
Fig. 22, Levee failure on southwestern bank of MRGO at Bayou Dupree. Note concrete sheetpile and levee transition washouts. (L. Harder, October 14, 2005).

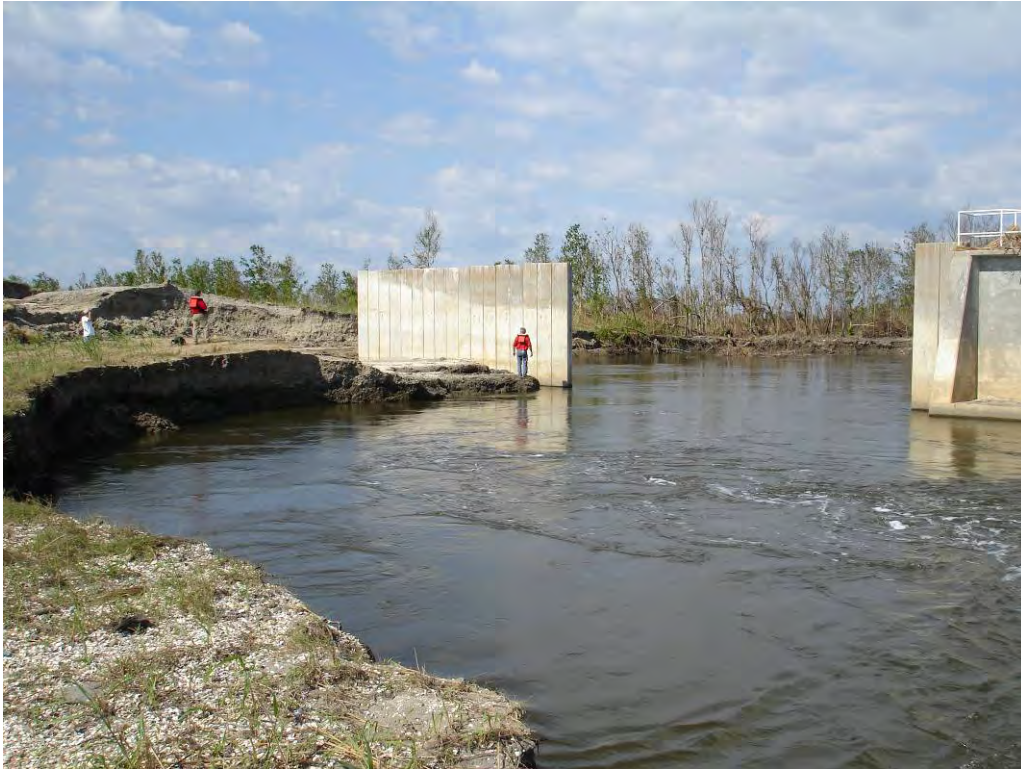
Fig. 23: Ground perspective of Bayou Dupree lock abutment failure (L. Wooten, October 6, 2005).

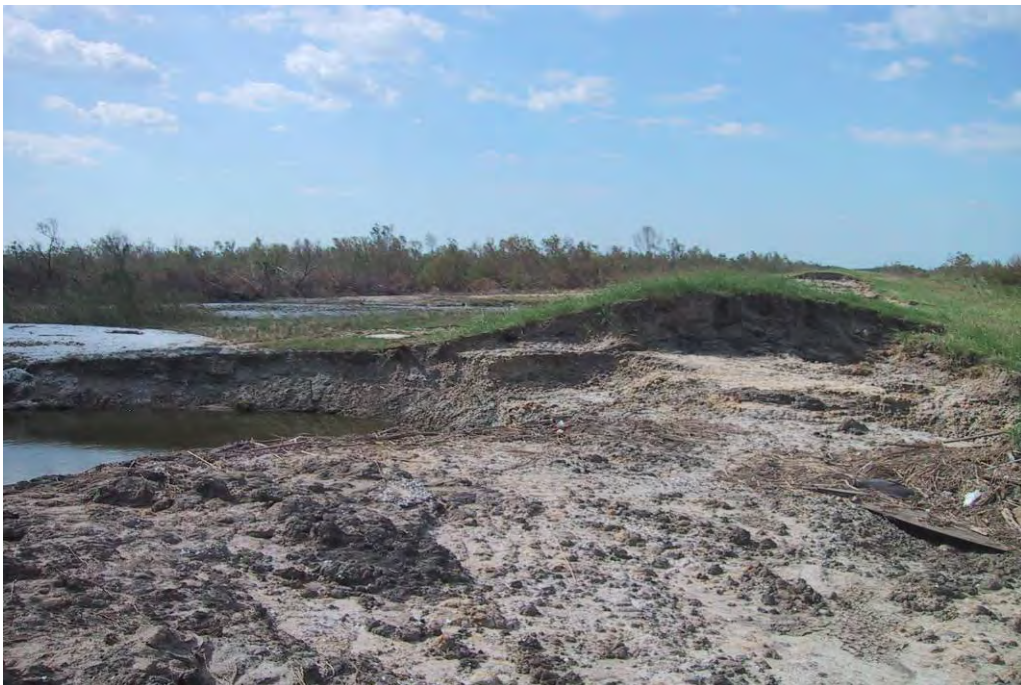
Fig. 24: Failure of earth levee on Southwest bank of MRGO adjacent to the Bayou Dupree gate (L. Wooten, October 6, 2005).

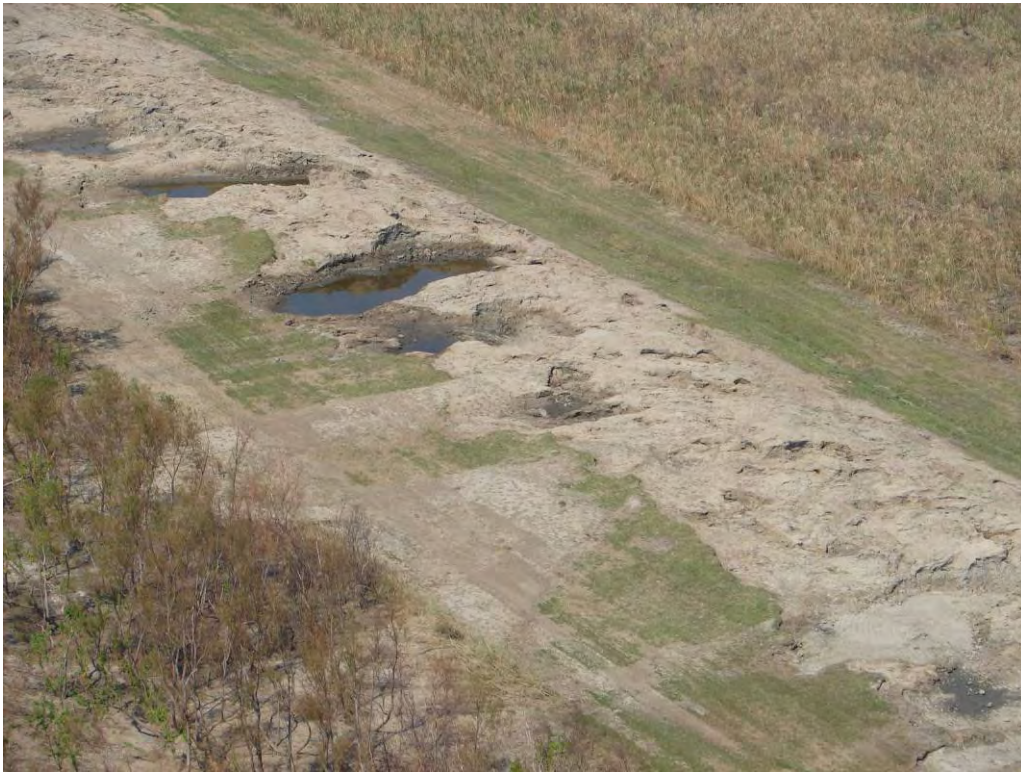
Fig. 25: Overtopping obliterated earth levee along southwestern bank of MRGO, within two miles southeast of Bayou Dupree. Note deep scour at the levee foundation level. (L. Harder, October 14, 2005).

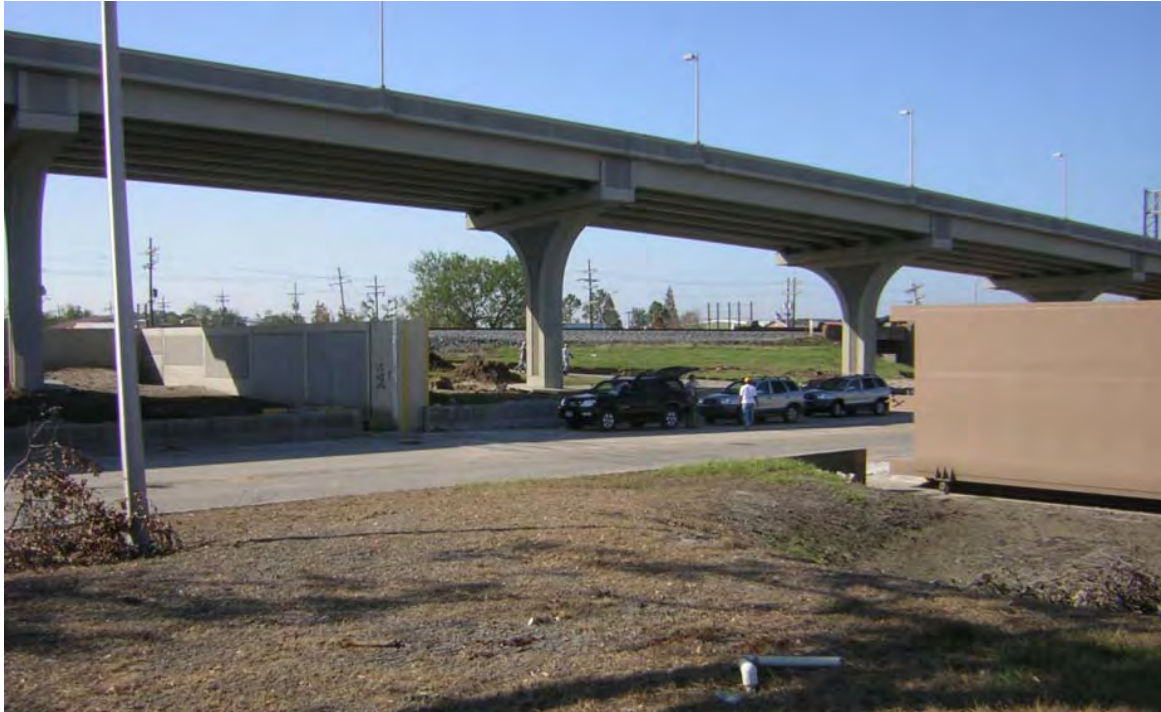
Figure 6.2: Scour through the earthen levee at the transition to the reinforced concrete flood gate structure.
